Re: February 2017 Monthly Progress Report  
Administrative Settlement Agreement and Order on Consent for Removal Action  
U.S. EPA Region 10 Docket No. CERCLA 10-2009-0255  
Gasco Sediments Site within the Portland Harbor Superfund Site

Attachment A Monthly Visual Monitoring Report for Pilot Cap Vicinity

# Visual Observations Log Form

**Project:** NW Natural – Gasco

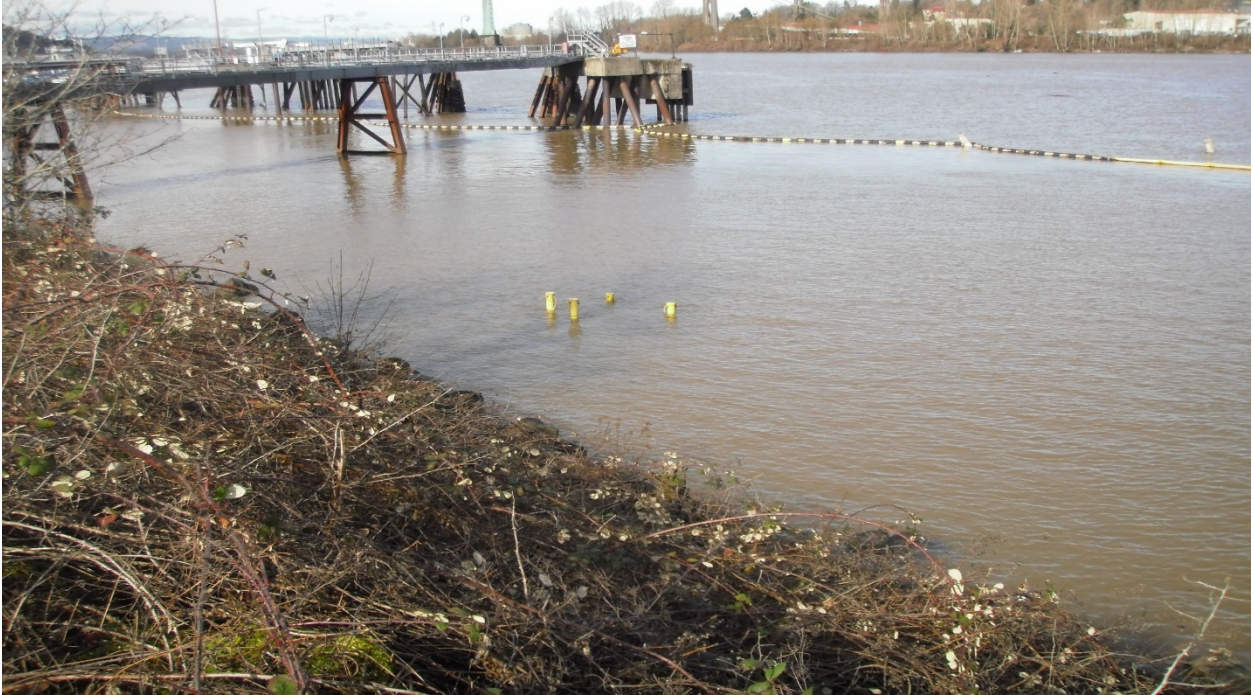
**Photo 1**

No erosion/deposition is evident along the shoreline. The shoreward extent of the cap was not visible due to high river water elevation and the organoclay mat material shoreward of the cap area could not be observed (Photo 1).

**River Level Currently Above the Extent of Sediment Cap (2/17/2017)**

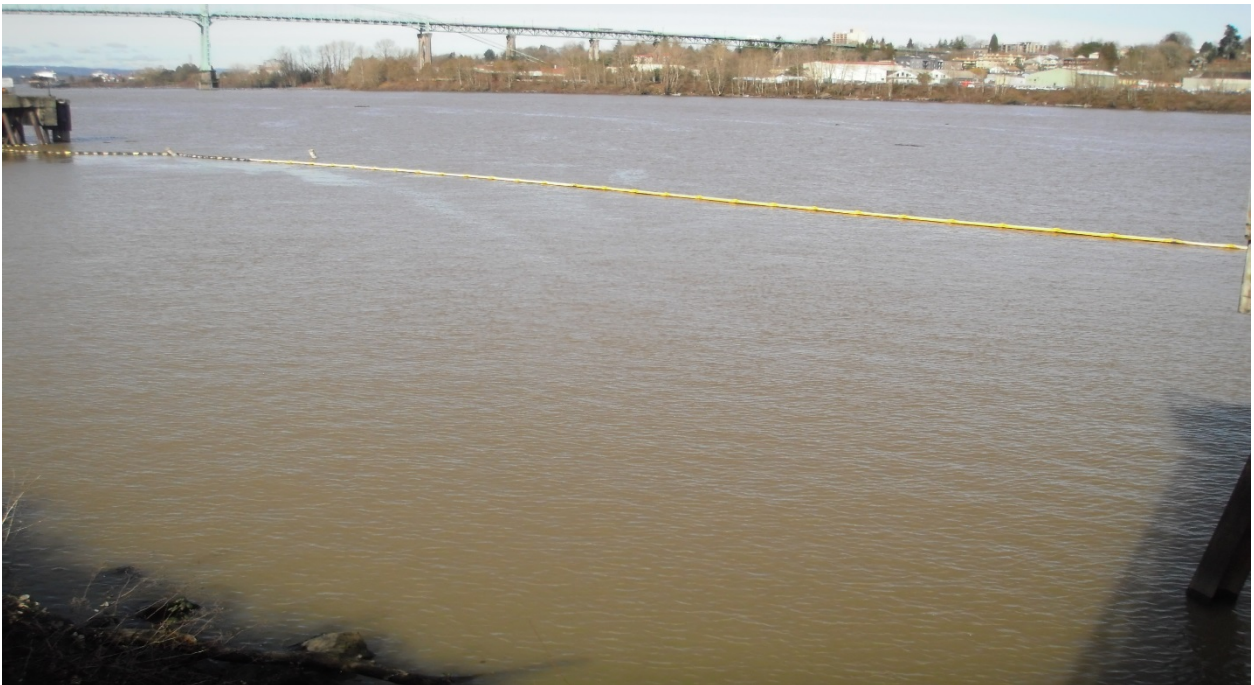
**Photo 2**

During the observation, the FAMM containment boom was placed across the cap area from the ship dock to the upriver dolphin. Two buoys that identify the cap area to mariners are in place as installed. The positions of the FAMM oil boom and warning buoys are shown in Photo 2.

**FAMM Oil Boom Placement and Mariner Warning Buoys at Pilot Cap Area (2/17/2017)**

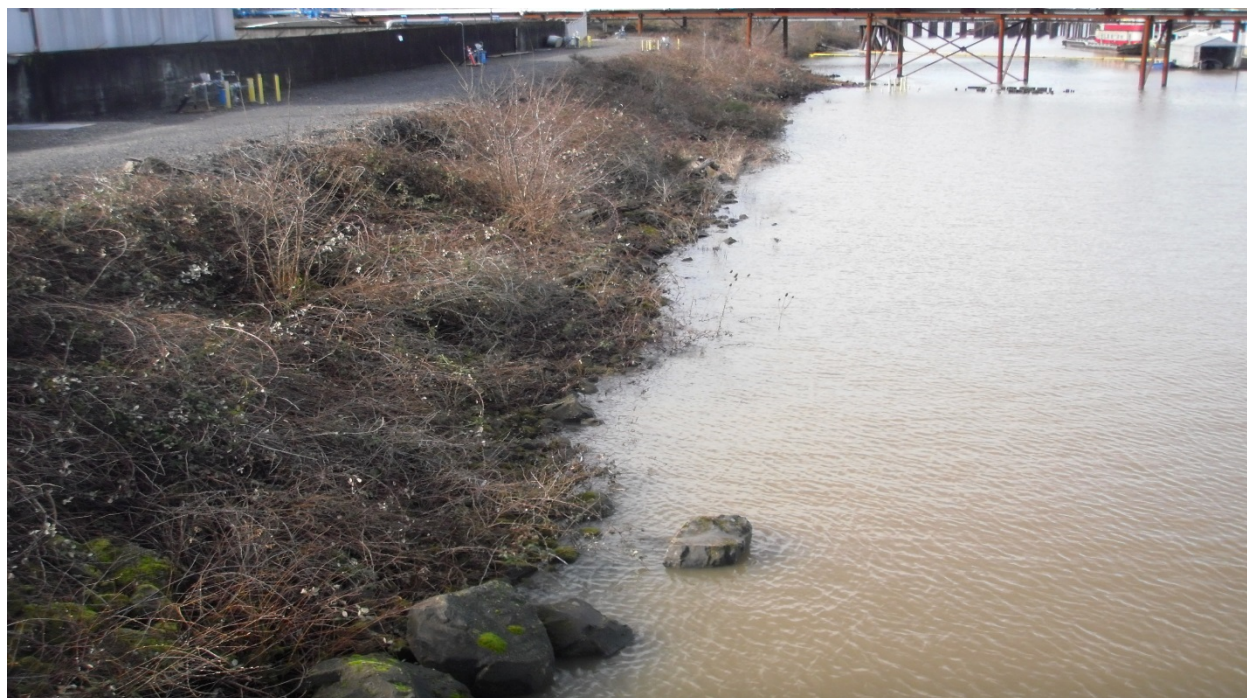
**Photo 3**

No sheen is evident in or around the cap area. Photo 3 shows the water surface and shoreline immediately downriver of the sediment cap.

**Conditions Immediately Downriver of Cap Area (2/17/2017)**
